## SUMMARY OF ANALYSIS HILL STREET AND ROUTE 6N

## INTERSECTION EVALUATION WORKSHEET

<b>Project:</b>	Putnam County Roundabout Evaluation
<b>Location:</b>	Putnam County (Various Locations)
<b>Intersection:</b>	Hill Street & Route 6N
<b>GPS Coord.:</b>	41°22'29.57"N, 73°45'44.10"W
<b>Traffic Control:</b>	Stop Sign (SB)
<b>Traffic Control Notes (if applicable):</b>	None
<b>Other Intersection Notes (if applicable):</b>	Sight Distance - 720' looking east/350' looking west. No Pedestrian Crossings.

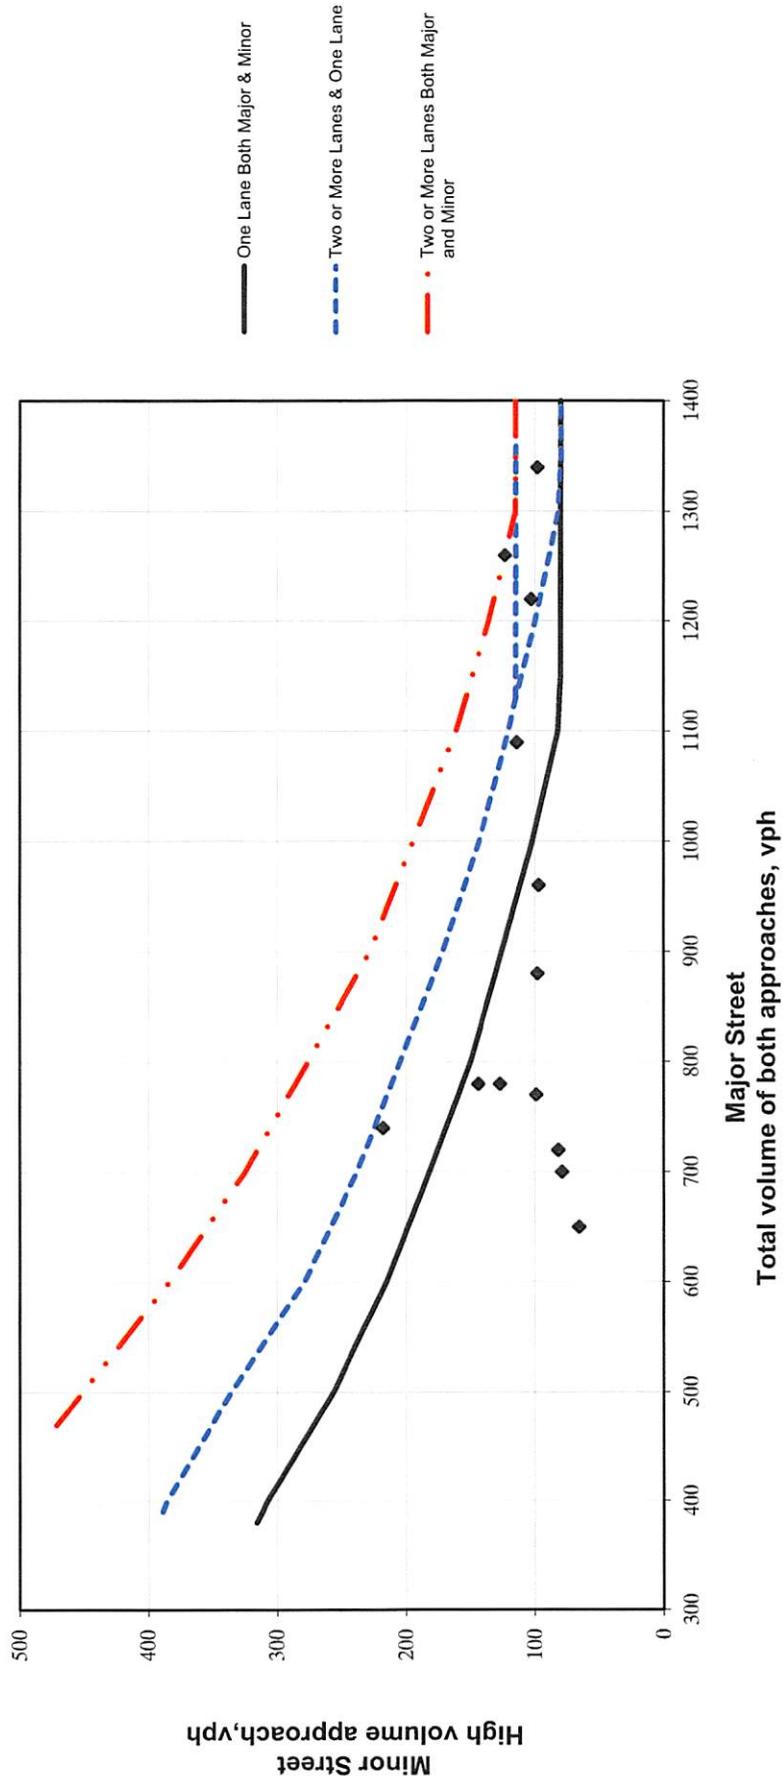
**Figure 4C-1. Warrant 2, Four-Hour Vehicular Volume**

Note: Points on graph represent hourly volumes. Points above the respective curve satisfy warrant, points below do not satisfy warrant.

A review of the hourly traffic volumes between 7:00 AM and 8:00 PM show that Warrant 1 (8-hour warrant) is satisfied with 9 of the 13 hours reviewed meeting criteria. Warrant 2 (4-hour warrant) is satisfied with 5 hours meeting criteria and Warrant 3 (peak hour warrant) is not satisfied with zero hours meeting criteria. Warrant 7 (crash experience) is not satisfied, as there were not 5 accidents per year susceptible to correction by signalization (left or right turn, or right angle accidents). The satisfaction of Warrants 1 & 2 combined with the existing over-capacity conditions indicates that the need for signalization, or similar treatment, such as a roundabout, is justified.

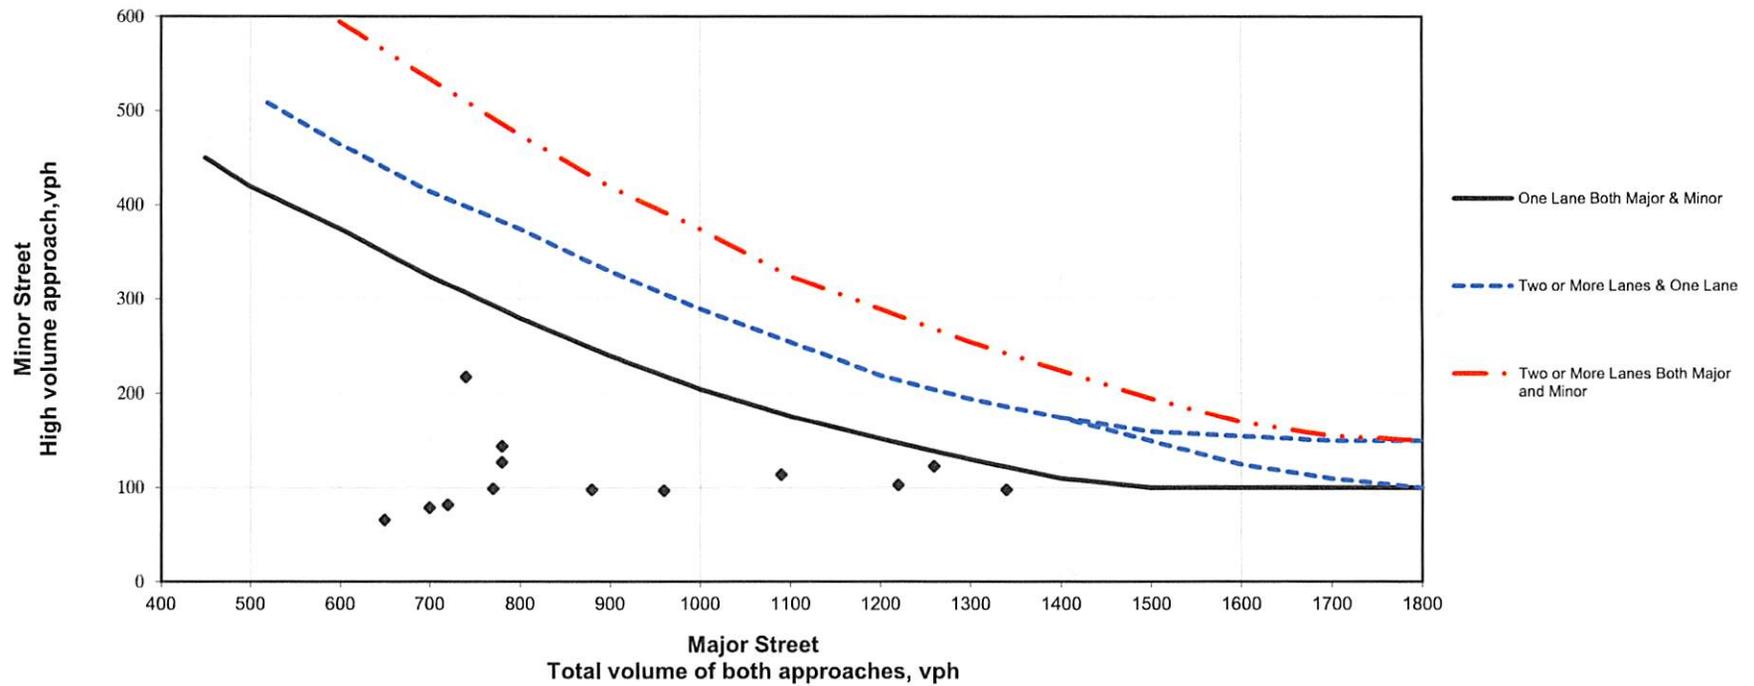
Figure 4C-3. Warrant 3, Peak Hour

Note: Points on graph represent hourly volumes. Points above the respective curve satisfy warrant, points below do not satisfy warrant.
